Technical Report ARWSB-TR-11017

Development of an Accelerated Hydrogen Embrittlement Test for Manganese Phosphated Steels

ARMAMENT RESEARCH, DEVELOPMENT AND ENGINEERING CENTER
Weapons & Software Engineering Center
Benét Laboratories

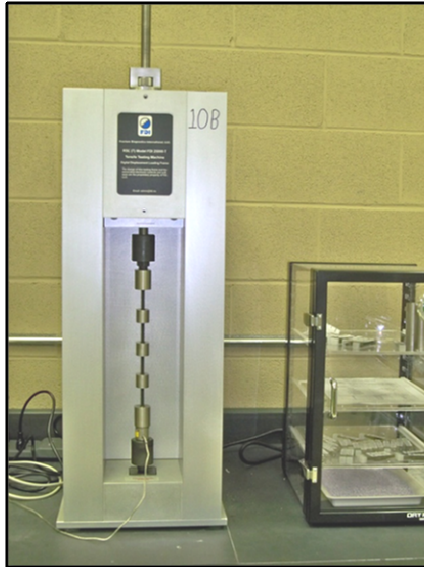
Figure 12. Four notched tensile specimens ganged together.

Some of these ganged tests raised the issue of potential bending in the load train which could bias the results (results in premature failure). Consequently, flat-sided tensile specimens were strain gauged in order to determine if ganging specimens resulted in additional bending. Test results indicated bending of approximately 3-16% regardless if testing was performed on a single specimen or four (4) specimens ganged together. Additionally, testing between different ISL machines demonstrated similar results. The amount of bending that was observed is similar to what has been reported in the appendix of ASTM E1012 “Standard Practice for Verification of Test Frame and Specimen Alignment Under Tensile and Compressive Axial Force Application”. Note that if any bending were to influence a test result, it would be a conservative test since the specimen would fail at a lower NFS.
